Effects of Hydraulic Stimulation on Coalbeds and Associated Strata

Report of Investigations 8260

By Curtis H. Elder

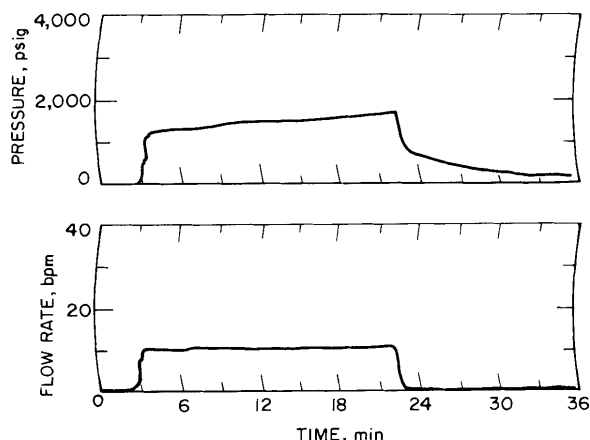
Two thousand gallons of gelled fluid was injected into the coalbed to fill all spaces in the coalbed around the borehole and initiate the fracture. The formation broke at 500 psig. The induced fracture was propagated into the coalbed with an injection rate of 10-1/2 bpm. The pad volume was followed with successive injections of 1,300 gallons of sand-laden treating fluid at 1/4 ppg (pounds per gallon) sand concentration, 650 gallons at 1/2 ppg, 1,750 gallons at 3/4 ppg, and 1,350 gallons at 1/2 ppg sand concentration. The tubing was cleared of sand with 250 gallons of treating fluid. An injection rate of 10-1/2 bpm was maintained during treatment at an average injection pressure of 1,586 psig. A maximum injection pressure of 1,700 psig was reached (fig. 3).

FIGURE 3. - Pressure and flow rate charts recorded during hydraulic stimulation.

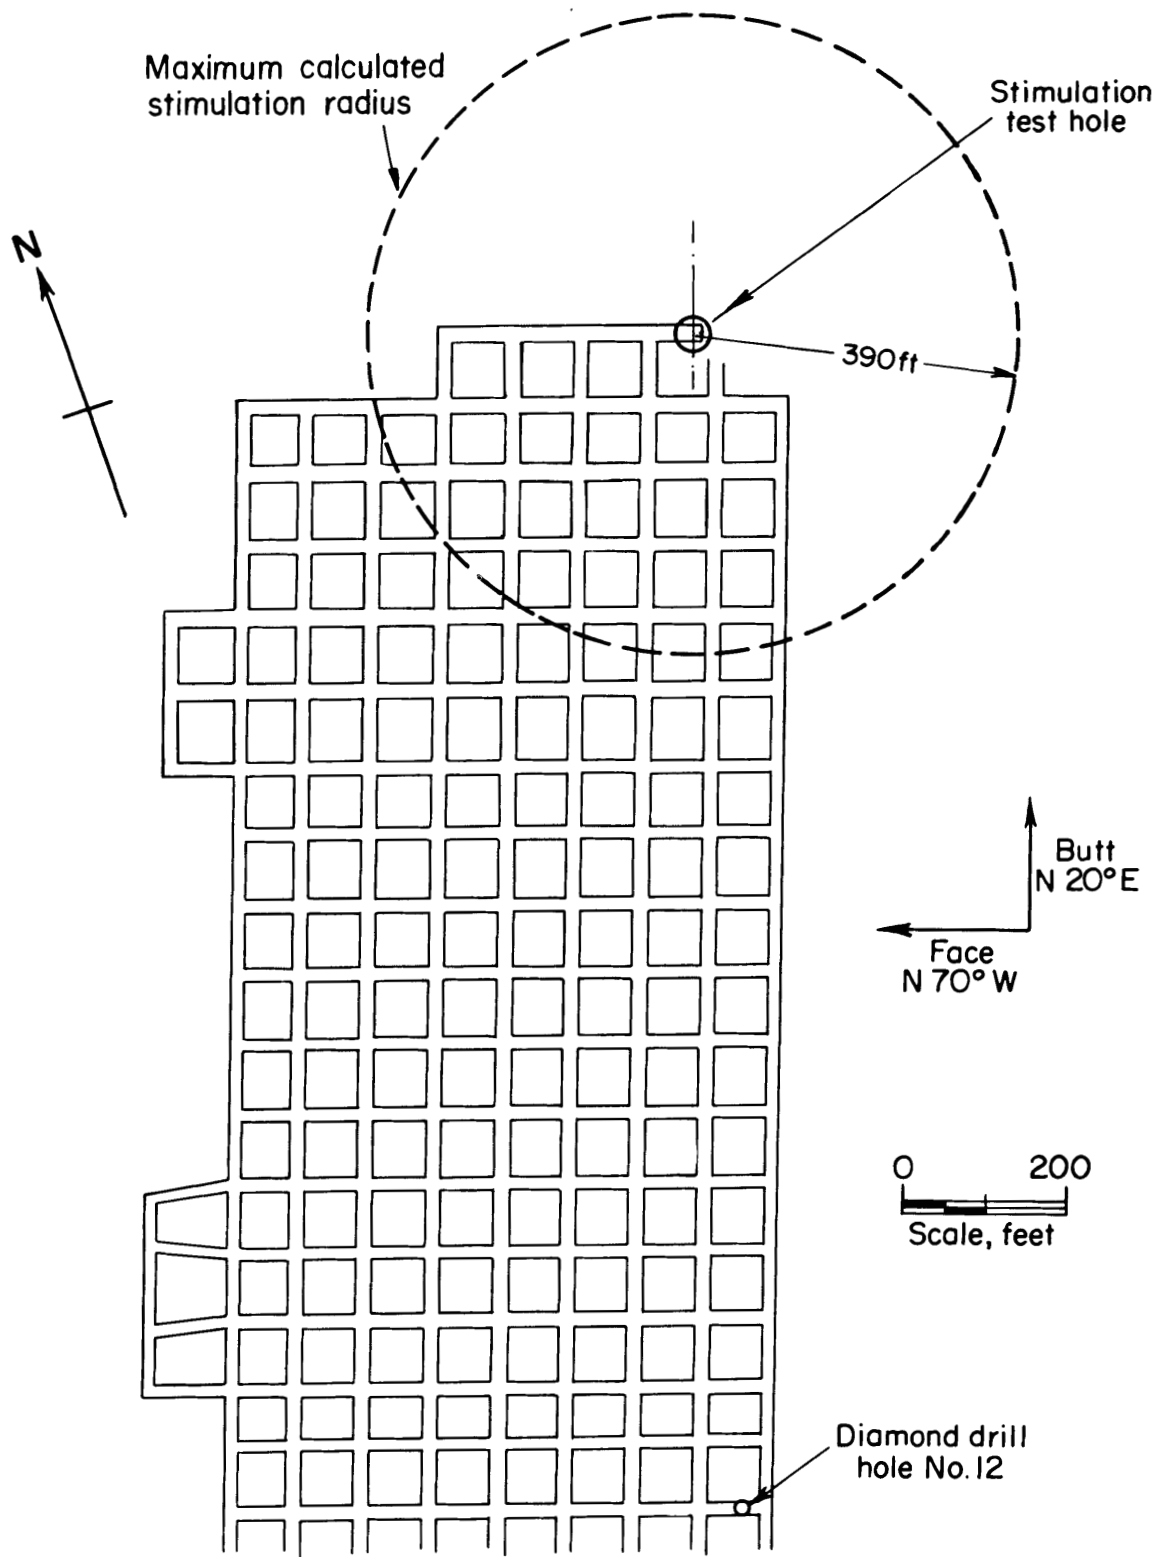
On June 12, 1974, the induced fractures were intercepted by mining. Twenty feet of vertical sand-propped fracture was mapped along the face cleat direction west of the borehole. The sand-filled fracture ranged from one-eighth to one-half inch in width, extending from the draw slate at the top of the coalbed to the mine floor. There was no evidence that the fracture extended into the roof or floor rock (figs. 4-6). Wide vertical fractures were propagated to the north of the borehole along the butt cleat direction. These fractures were 1/2 to 2-1/2 inches in width and were packed with the propping sand (figs. 7-8). They extended from the base of the draw slate to the floor. Again, no evidence was found to indicate that the induced fractures along the butt cleat direction penetrated the roof (fig. 9) or floor rock.

FIGURE 4. - Mine development at time the hole was intercepted.

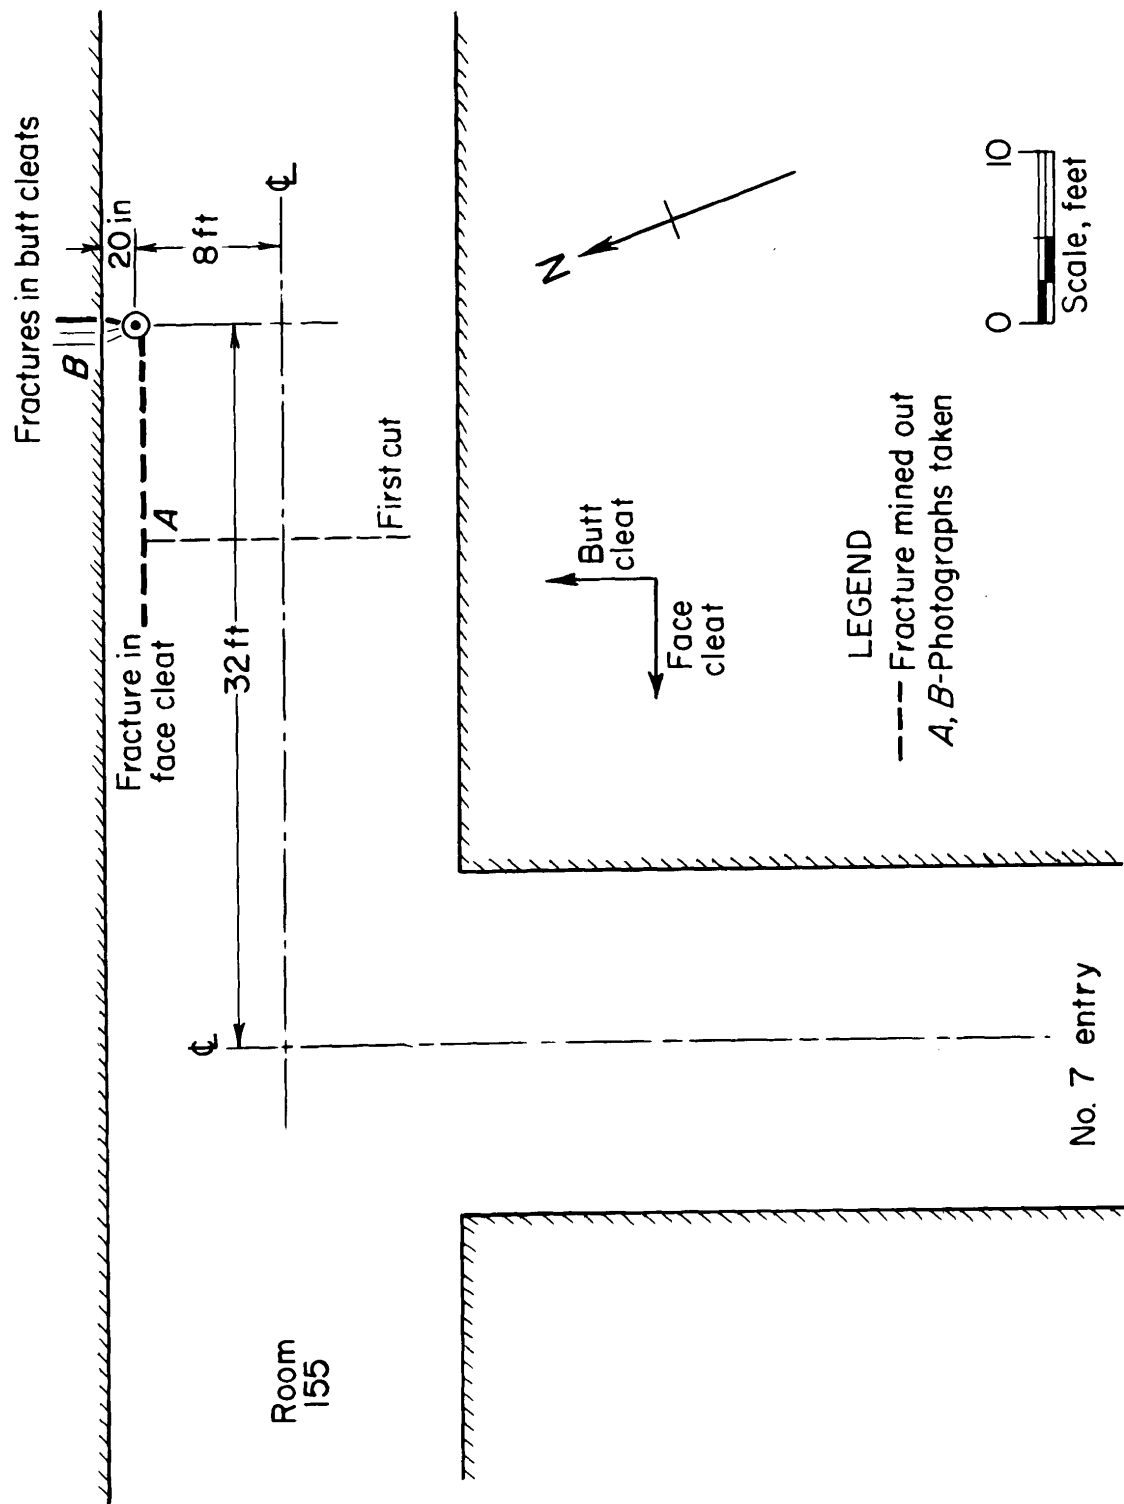
FIGURE 5: - Induced fracture orientation relative to mine entry development.

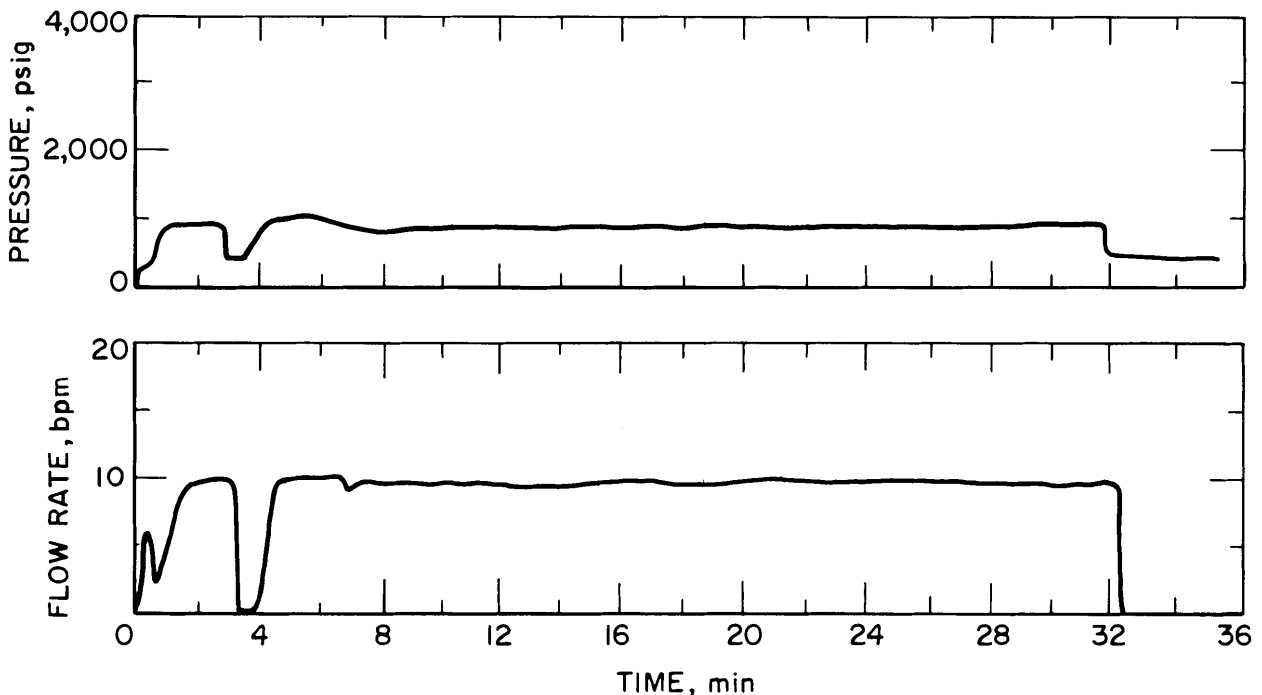
2,000 gallons at 1/2 ppg; 1,800 gallons at 3/4 ppg; and the final 3,200 gallons at 1 ppg. The average injection pressure was 900 psig, but a maximum injection pressure of 1,000 psig was reached (fig. 12). After treatment, the test hole was put back on gas and water production. The hole was not producing a significant amount of gas, perhaps owing to formation damage during drilling. Gas flow increased from 10 to 4,300 cfd. Testing of the No. 6 coalbed before stimulation had shown it to have a low gas content and low permeability, so the flow increase was substantial.

FIGURE 12. - Pressure and flow rate charts recorded during hydraulic stimulation.

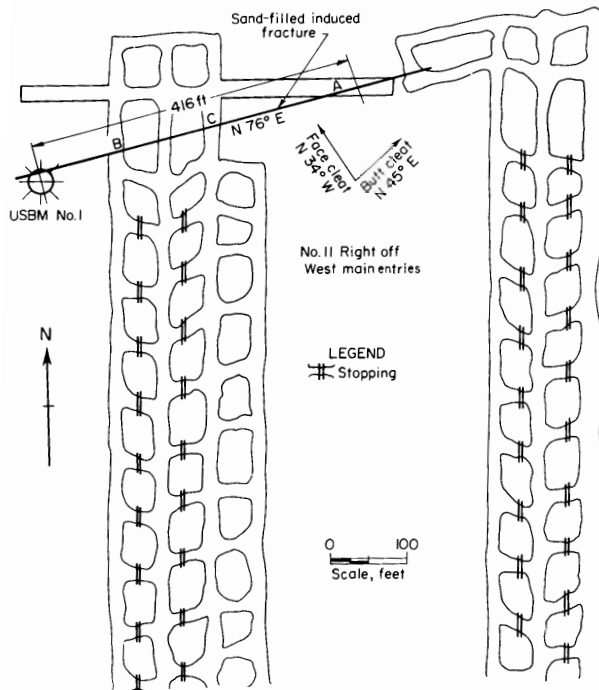
The induced vertical fracture packed with propping sand was intercepted by mining in May 1974. The induced fracture was propagated in a direction of N 76° E from the borehole. It was mapped across four entries of the No. 11 Right entries off the West main entries of the mine (fig. 13). The induced vertical fracture did not follow the directions of the face or butt cleat; it followed a path subparallel to the axis of a small anticlinal fold on the flank of the coal basin (fig. 14). The stimulation created a single vertical fracture in the coalbed. A small amount of water drainage from the fracture alerted the operator of the continuous miner that the sand-filled fracture had been mined through. The fracture was mapped for 416 feet from the borehole. The sand-propped fracture extended vertically from the roof shale to a hard shale parting approximately 2 feet from the bottom of the coalbed. The fracture was 7 feet in height. It is normal practice in this mine to leave 1 foot of roof coal during mining to protect the shale overlying the coalbed from air, moisture, and weathering.

FIGURE 13. - Induced fracture orientation as related to mine entry development at Inland mine.
